Manhole Inspection Summary

Manhole # S01GG2009MH

Insp Date: **7/12/06 10:06 AM**

Location Address: **terry dr**

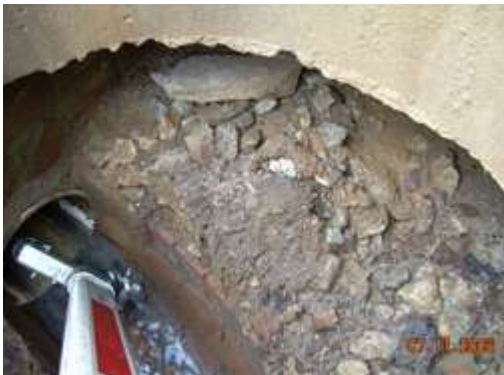
Defect

Condition: ☐ Sound ☐ Cracked ☐ Root Intrusion ☐ Deteriorated ☐ Leaks ☒ **Debris**

debris on the bench

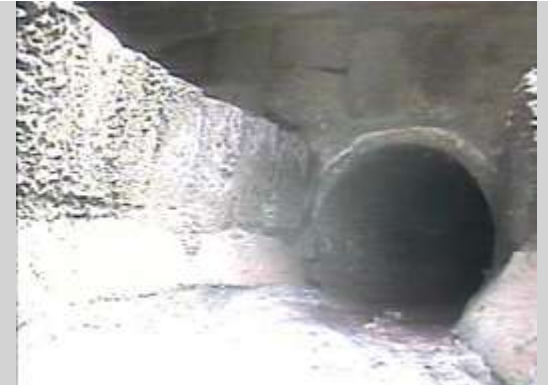
8 in. Circular Gravity Sewer Pipe Out @ 12 O'Clock

Pipe Material: **Clay** ☐ Pipe Lined

Invert Depth: **3.69** (ft.) Flow Characteristics: **Fast**

Deposits: ☒ None ☐ Mud ☐ Sludge ☐ Debris ☐ Grease

Infiltration: **None** Pipe Seal Cond: **Sound**

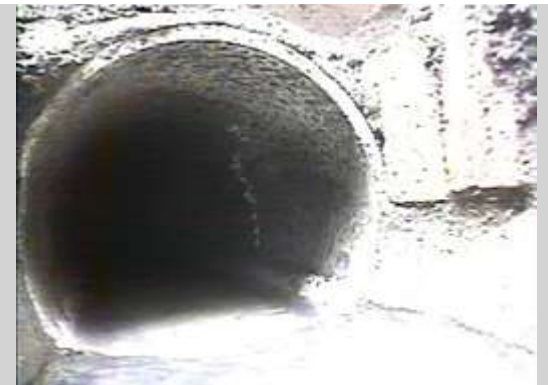
8 in. Circular Gravity Sewer Pipe In @ 5 O'Clock

Pipe Material: **Clay** ☐ Pipe Lined

Invert Depth: **3.60** (ft.) Flow Characteristics: **Slow**

Deposits: ☒ None ☐ Mud ☐ Sludge ☐ Debris ☐ Grease

Infiltration: **None** Pipe Seal Cond: **Sound**
